Waianae District,
Island of Oahu, Hawaii

July 2022

Final Environmental Assessment

Waianae Wastewater Treatment Plant Outfall Improvements and Rehabilitation

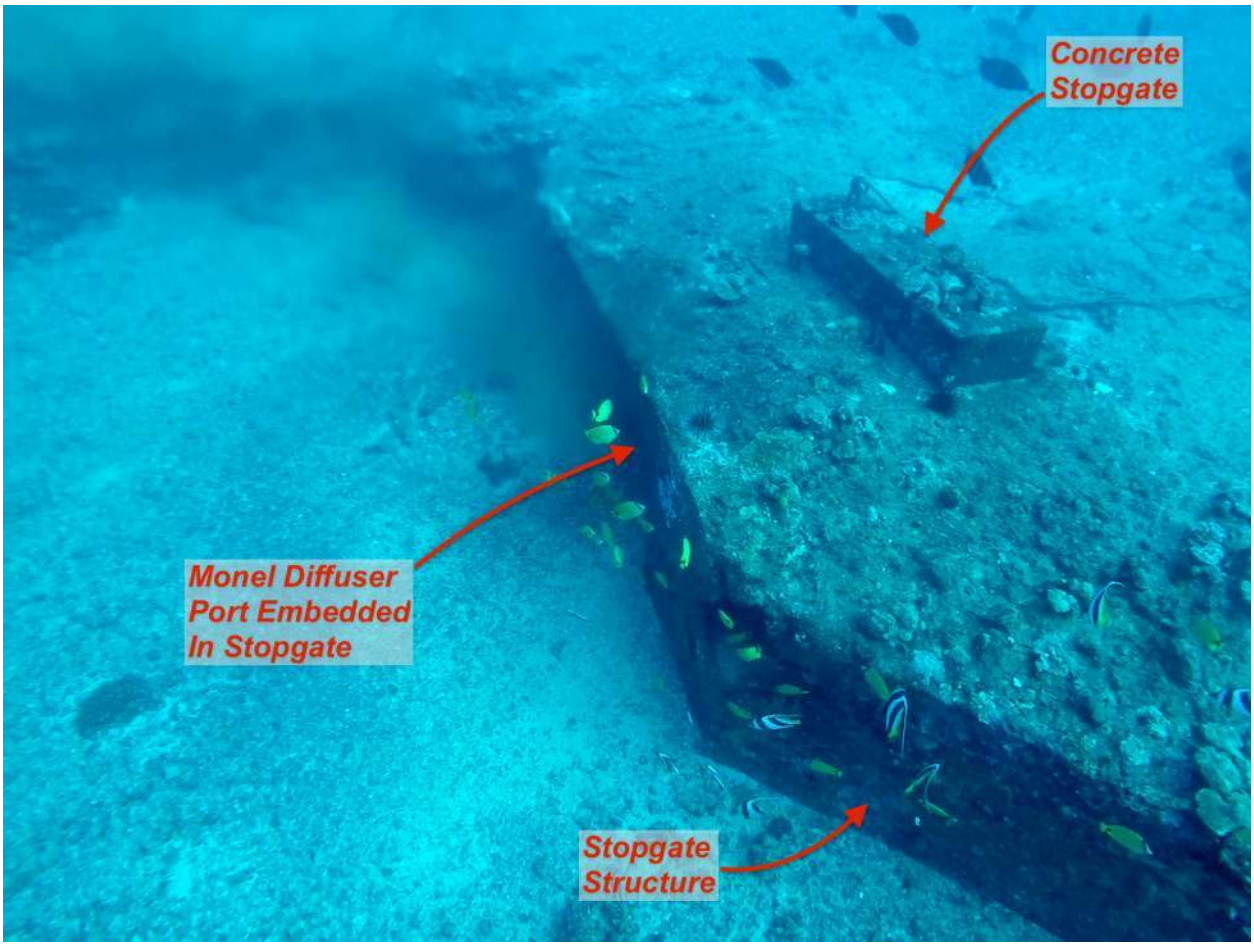
- At no point during the inspection were the actual 36-inch or 42-inch RCP joints visible. This is a good indication, as it is consistent with design and implies stability.
- The stopgate structure, special wye structure, and manhole risers visibly appeared to be in good operating condition, with no significant cracks or spalls evident to inspectors. A majority of the mass of most structures were embedded in the ocean floor and appeared well supported with no significant evidence of scour or failure of supporting trench walls. Representative photographs of the stopgate structure and special wye structure are provided in Figure 4-10 and Figure 4-11, respectively.

Figure 4-10. Stopgate structure, located at end of diffuser leg, which is also the outfall terminus.

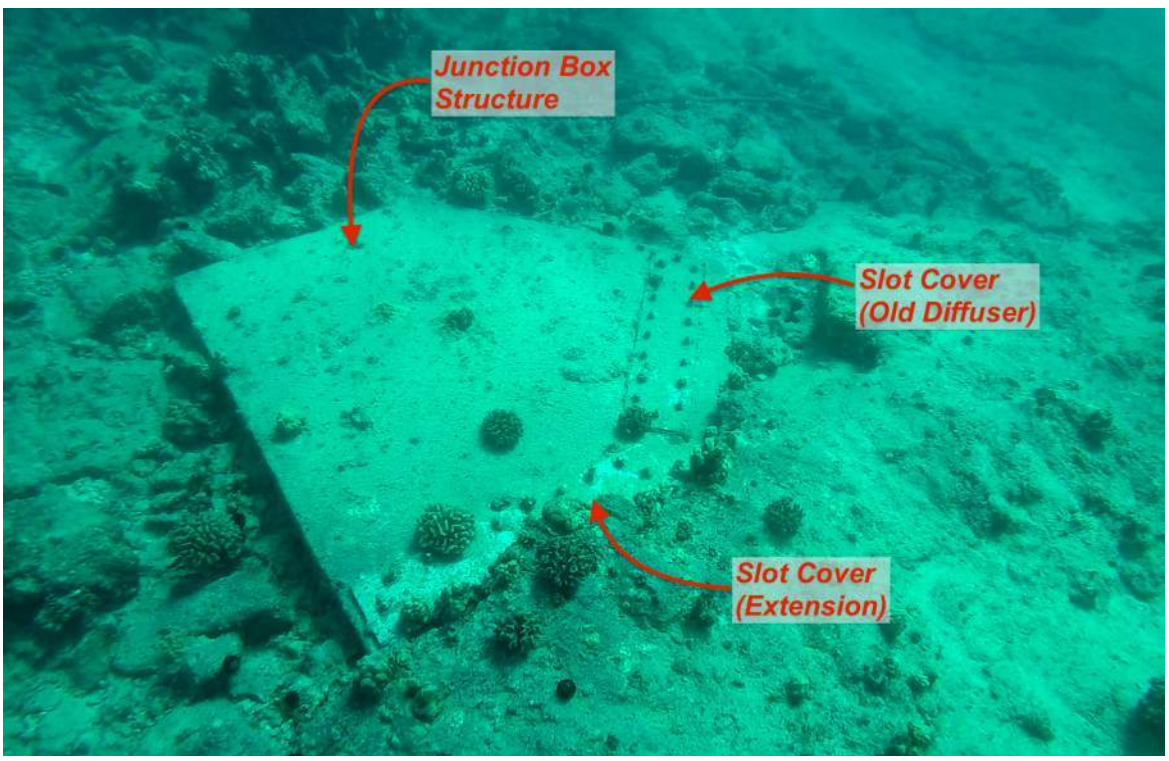
Figure 4-11. Special wye structure, looking NE, with stainless steel slot covers visible at lower right edge.

- The concrete structure which forms the special wye structure at the end of the original outfall had been repaired for leakage in March 1996. The slot covers at the special wye structure showed no signs of degradation and appeared to be in good condition, as shown in Figure 4-11. No leaks were observed during this inspection, indicating the 1996 repairs are effective.

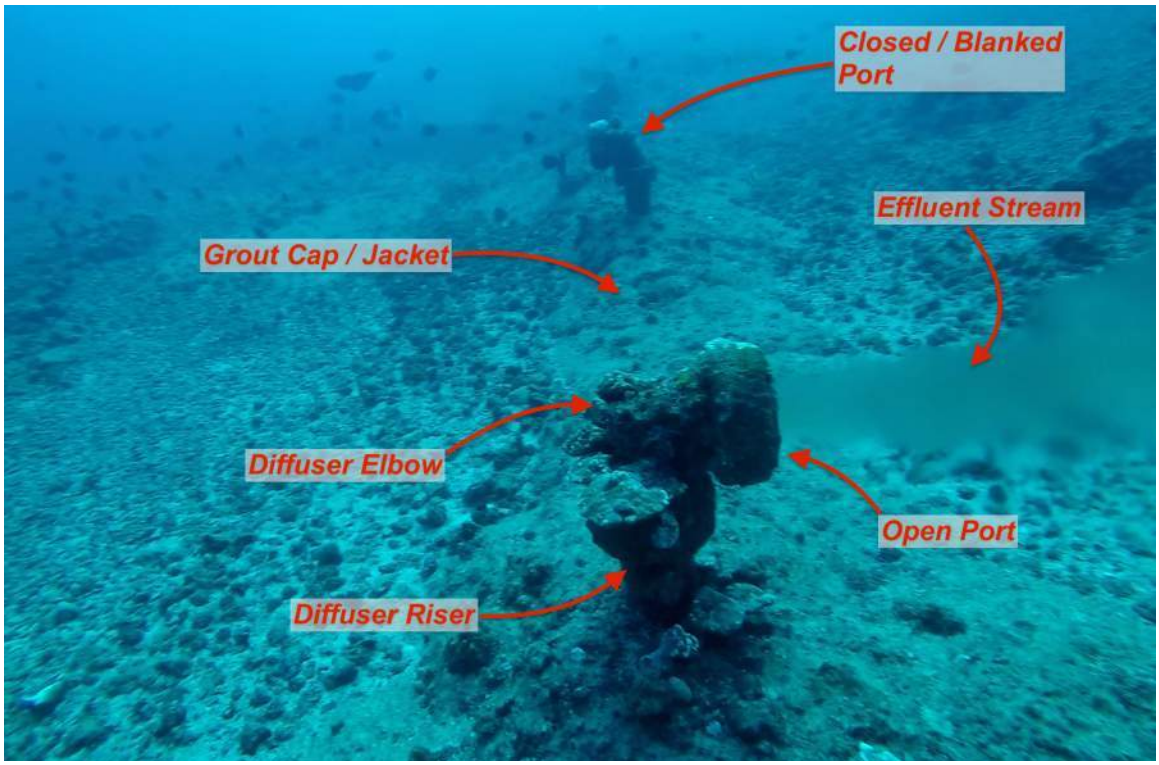
- All 42 fiberglass diffuser ports, including the exposed end of the riser, the 90° elbow section, and connecting hardware, appeared to be in good operating condition with no blockage or restrictions of any of the 21 open diffuser ports, and no visible leaks from the 21 closed diffusers, which were blanked with fiberglass blind flange plates. A summary of diffuser port conditions is presented in Table 4-3, located at the end of this section, which provides the existing status of each diffuser port by number. Port numbering begins at the upstream start of the diffuser leg (approximately station 30+70), just before Manhole D, and increases towards the outfall terminus. Regular flow was also observed from the monel pipe diffuser seated in the stopgate. Figure 4-12 illustrates typical conditions along the diffuser leg, while Figure 4-13 pictures effluent flowing from the final diffuser of the outfall, which is simply a monel pipe embedded in the stopgate.

Figure 4-12. Looking northward along the diffuser leg, with open diffuser in foreground, blanked diffuser behind.

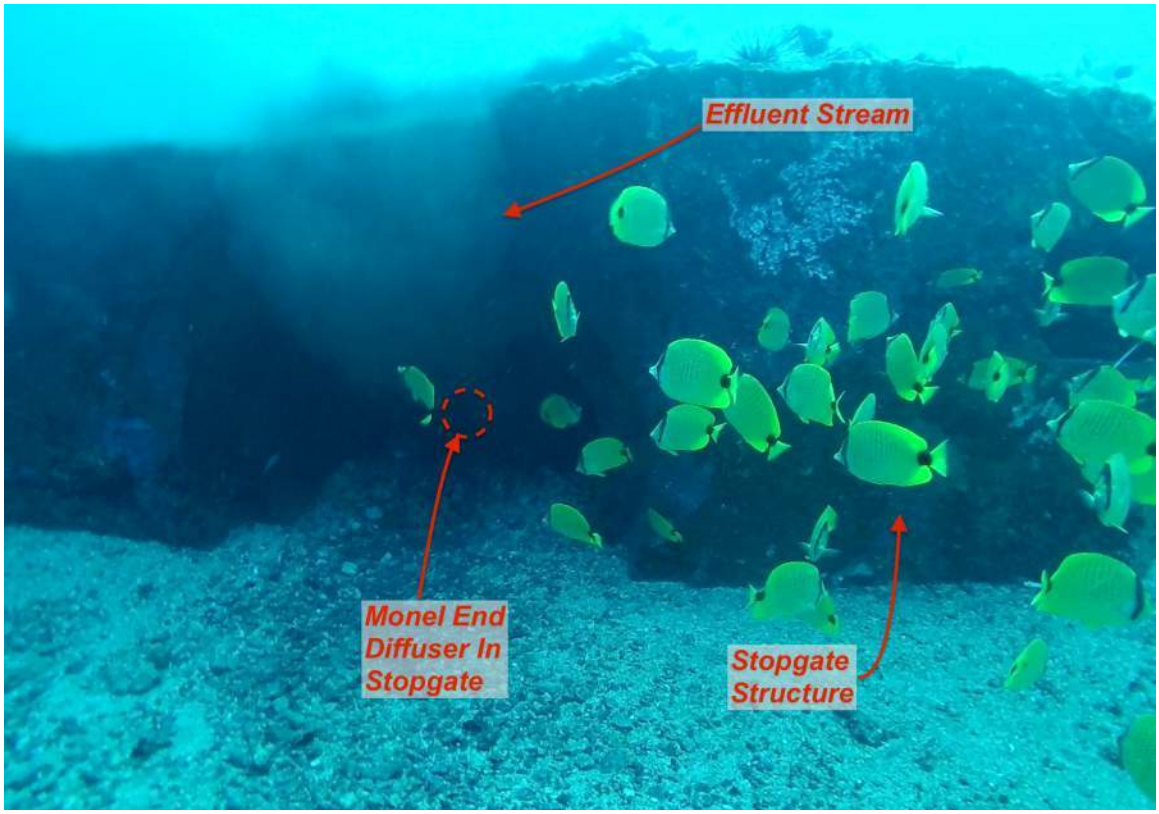
Figure 4-13. Stopgate structure, with single monel diffuser port

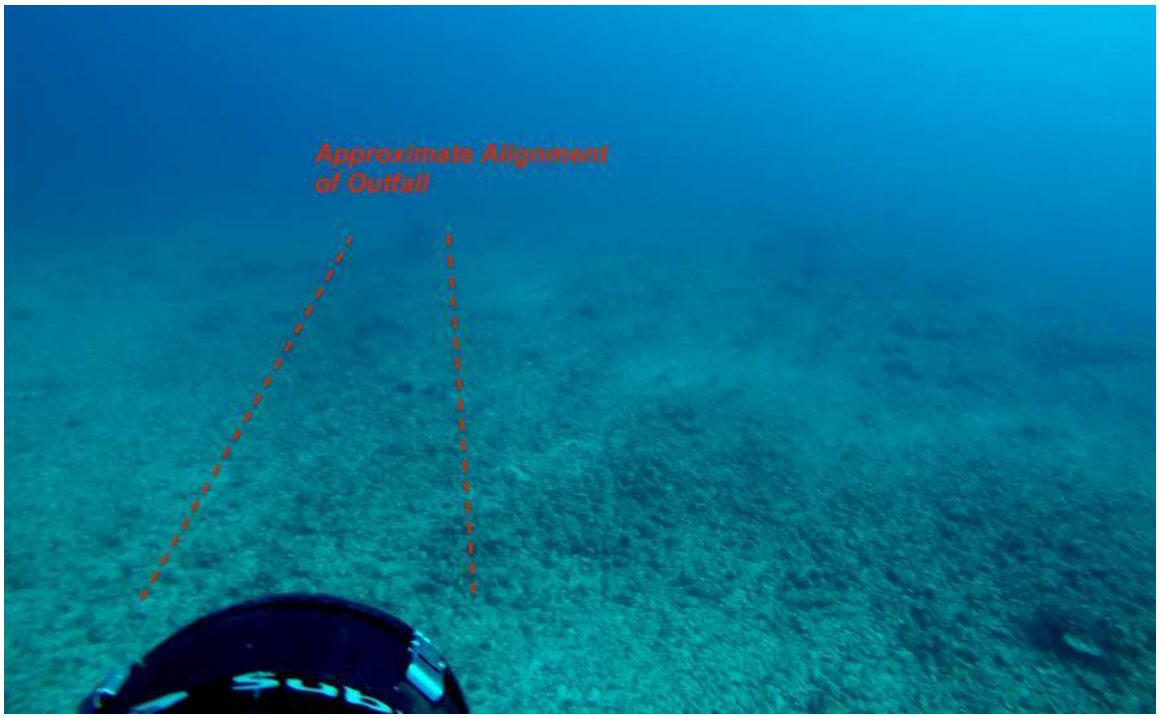
- No indications of significant scour were observed along the outfall, which was as expected since the outfall is buried and trenched into hard material over the vast majority of its length. The outfall was so well buried in fact, that in some locations it was indiscernible from the natural seafloor, such as the area shown in Figure 4-14 between stations 23+00 E and 26+00 E.

Figure 4-14. Outfall completely hidden, approximately between station 23+00 E and 26+00 E

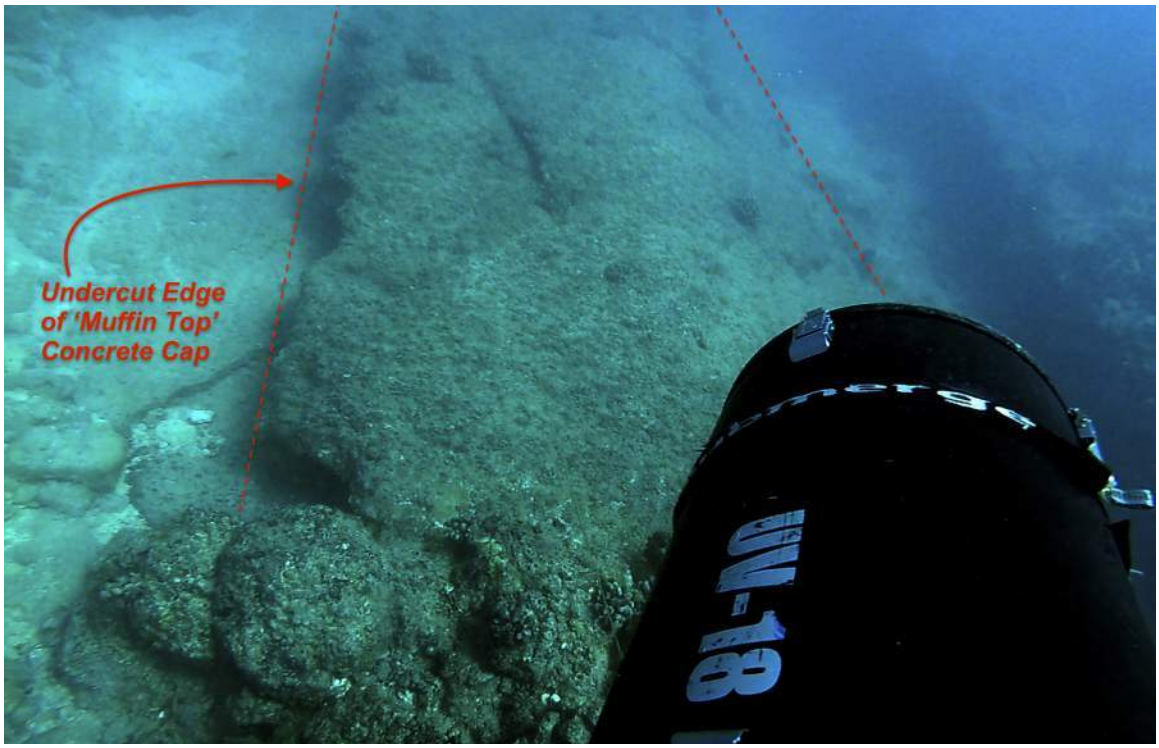
- During earlier visual inspections of the shoreline landing and above-water portions of the outfall conducted in August 2015 and July 2017, an area of partial erosion and scour of the shoreline limestone, sandy sediments and sedimentary rock was noted. The erosion resulted in a collapse of approximately 50 to 75 ft of the south trench wall seaward of the valve box, in the intertidal zone. Loss of the section of supporting south trench wall resulted in undermining of the pipe and development of a void space below the pipe. An unsupported span of approximately 20 ft currently affects the pipe. This condition was previously noted in an SEI memorandum, dated 26 June 2017. Emergency repair of this area by injecting tremie concrete under the pipe has been scheduled. Several locations along the outfall were noted where the concrete jacket or cap formed a mushroom-shaped profile or "muffin top" that appeared to have a slight undercut along the edge of the pour. This appeared to be the result of construction methodology and concrete form over-pour, and did not appear to be a sign of active erosion, undermining or instability. An example of this condition can be seen in Figure 4-15.

Figure 4-15. Concrete jacket/cap with edge voids creating a "muffin top" profile

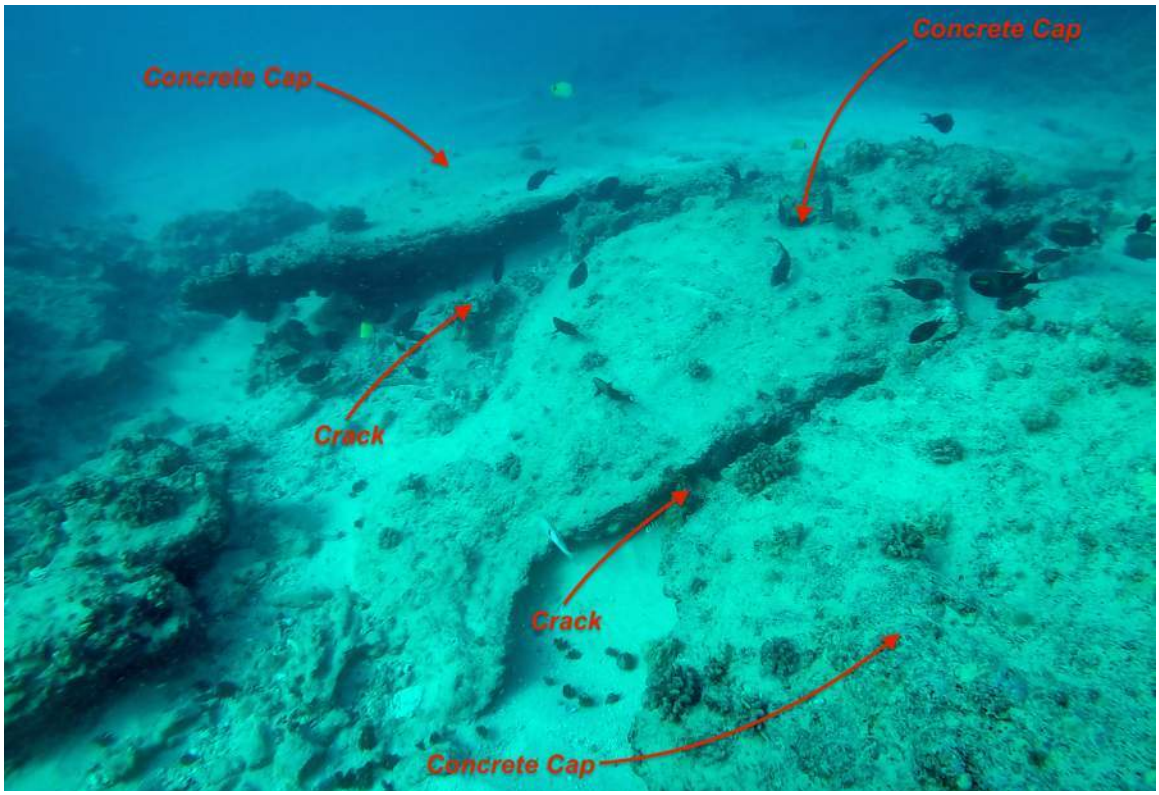
Figure 4-16. Concrete jacket/cap broken into three massive pieces

- Near station 02+50 E, the concrete cap was found broken into several large masses with large visible voids underneath the edges of the breaks. No underlying gravel, stone or RCP joint was visible at this location, and it appears the damage was limited to the concrete cap. A photograph of this location is presented in Figure 4-16.

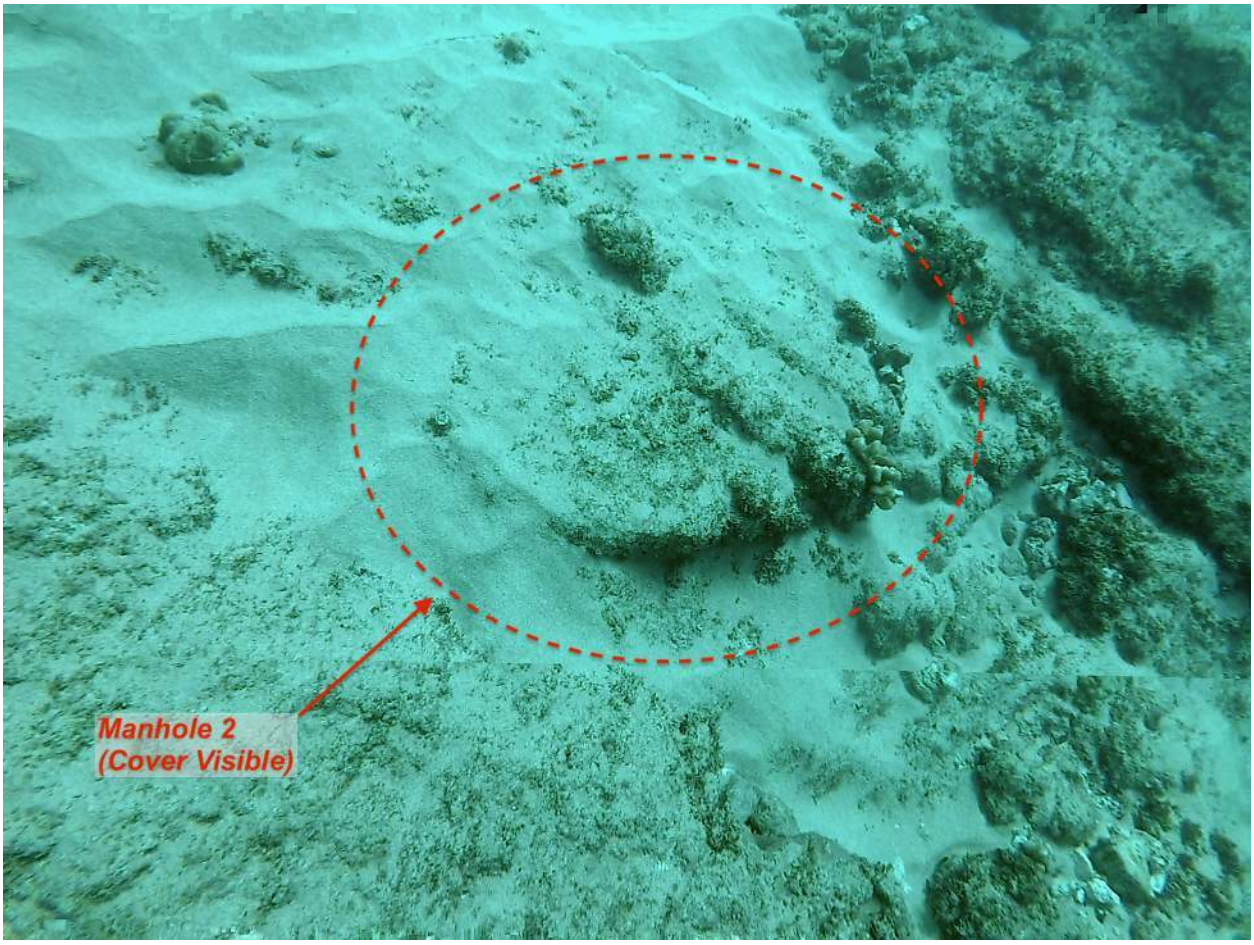
Figure 4-17. Manhole 2, first underwater manhole on the original 36-inch pipeline

Underwater inspections performed by SEI revealed advanced corrosion on the cast iron covers at Manholes 2, 3, and 4. Allowing the corrosion to continue on the pressure manholes could result in significant leaking of effluent. The use of sacrificial anodes is not a potential solution at this point as the corrosion is already too advanced to have any significant effect on the life of the cast iron pressure manhole. The pressure manhole assembly and hardware need to be replaced with a corrosion resistant alloy or capped to mitigate potential leaking.

The Proposed Action includes capping existing cast iron Manholes 2 through 4 on the original 36-inch-diameter pipeline. New precast concrete caps would be provided to fit over the existing pressure manhole covers and would be filled with grout. Uplift forces on the new precast concrete caps would be resisted by the dead weight of the cap and grout and by stainless steel hardware anchored into the existing concrete jacket surrounding the outfall pipe with epoxied anchors suitable for underwater applications.

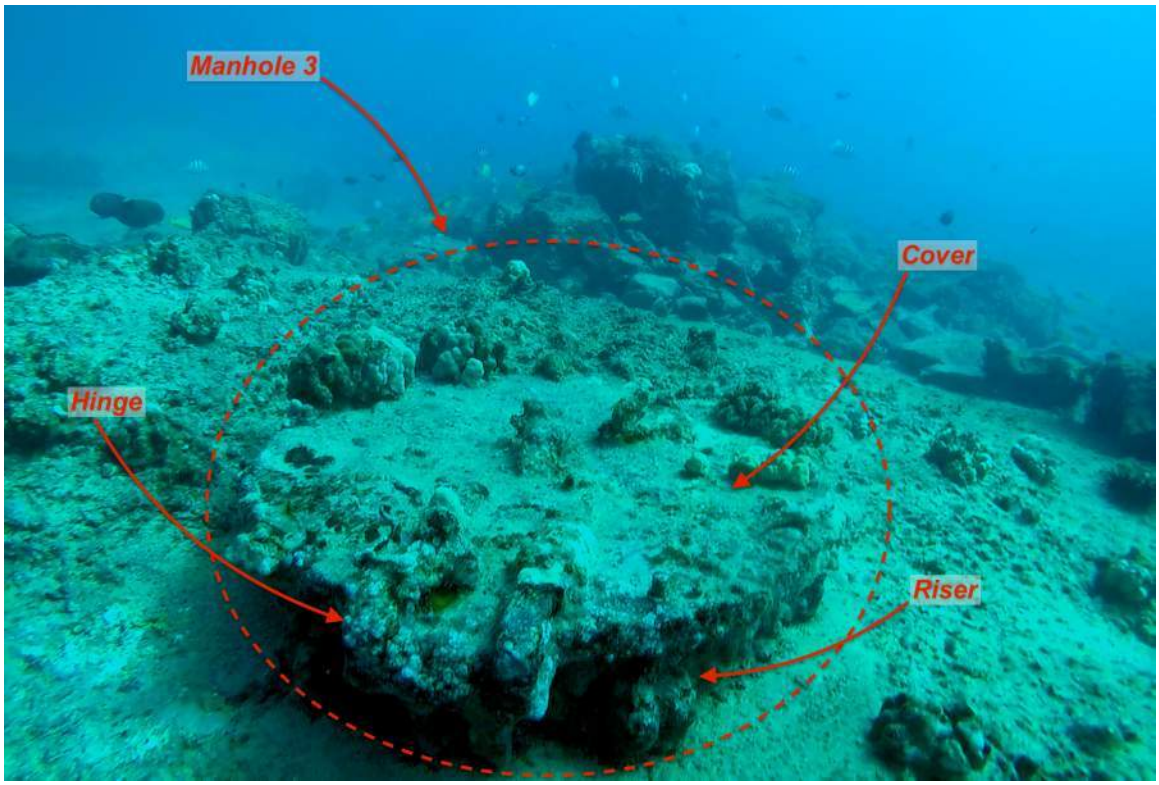
Figure 4-18. Manhole 3, on the original 36-inch pipeline

- All seven of the underwater manholes were located (Manhole 1 is located on the valve box at station 00+00, which is onshore), and showed no visible signs of leakage or significant damage to the manhole riser, gasket, or cover. Manhole 2, the shallowest manhole on the outfall, was found nearly completely buried within the sand and seafloor sediments, and required partial excavation for inspection. Conditions of the metallic manhole covers varied depending on the type of metal used, and is discussed in more detail in the hardware section. Photographs of each manhole are illustrated in Figure 4-17 through Figure 4-23, where they are presented in sequential order starting from the shallowest (inshore) manhole and proceeding in the offshore direction to the deepest.

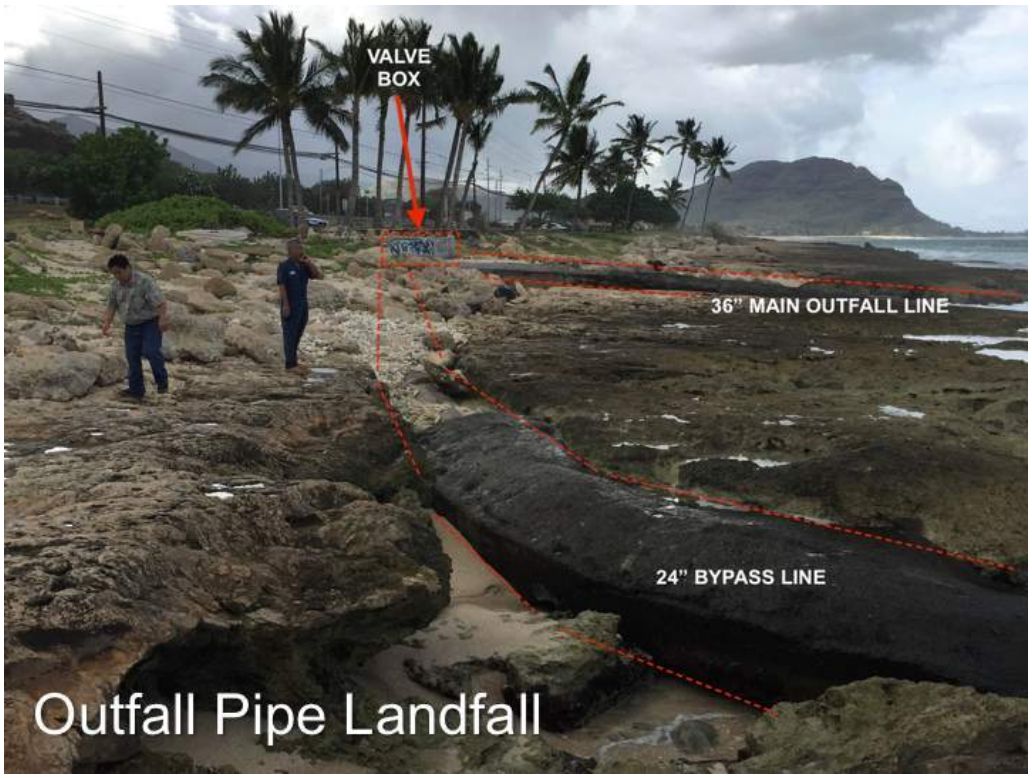
Figure 5-2. Outfall landing, with by-pass line (foreground) and main barrel (background) with MH 1 and valve box

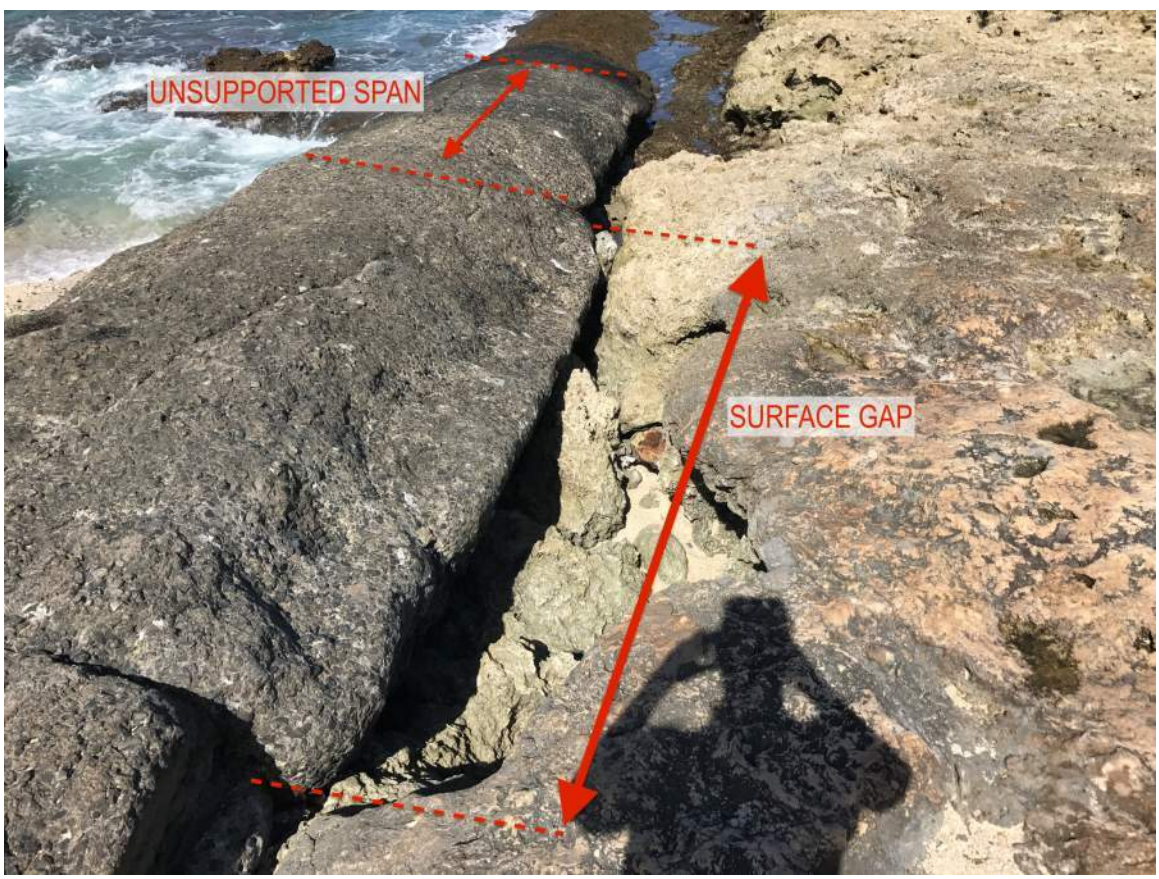
Figure 5-11. Surface gap and voids along north flank of pipeline near waterline/shoreline
